## Iron Elbow 90° and T-shape fittings with internal Polytec<sup>®</sup> wear-resistant coating

### Technical Specs

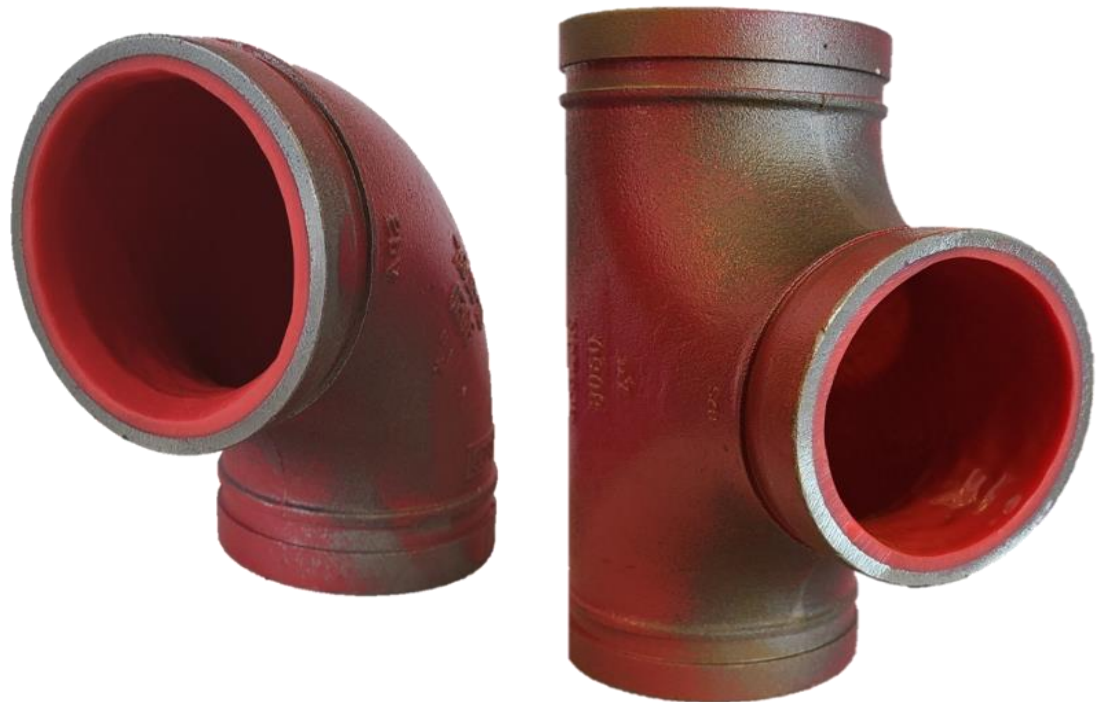
- Specific Fitting Shape **90° Elbow and T shape fittings**
- Finish **Painted**
- For Pipe Schedule **40/80**
- Fitting Sides **Grooved**
- Standards **ANSI B31.1, ANSI B31.9, NFPA 13**
- Pipe Fitting Material **Ductile Iron**
- Fitting Size **Ø 3in/4in/5in and more upon requests**
- **Application** Abrasive slurry transport, concrete, liquid, etc
- **Pipes in other shapes and sizes available upon request**

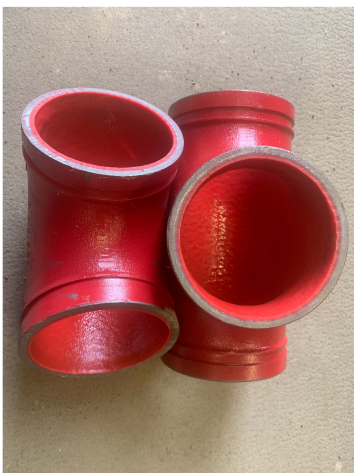
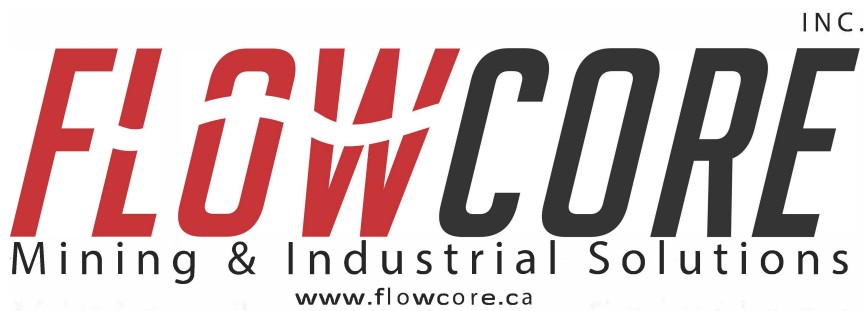
**The Challenge:** Backfill tees and elbows are frequently failing when backfilling underground stopes creating a safety hazards and large spills . Clean up and changing of the failed elbows and tees is costly in man hours and downtime ,resulting in lost of production.

**Our Solution:** After reviewing backfill properties and flow-rates, Installation of Polytec coated tees and elbows at a shore rate of 80 was recommended.

**Improvement:** no reported failures of Polytec tees and elbows after one year in service.

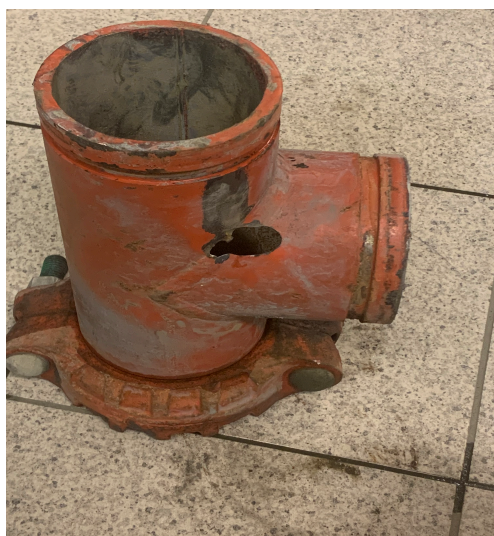
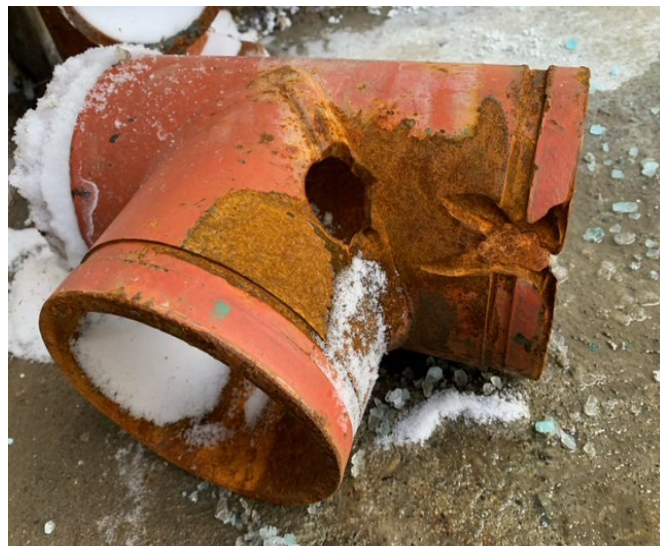
Attached is a picture of two of our failed backfill "T"s. These components generally last two weeks to a month. We installed a Polytec "T" in one of our high wear areas last year and it is still in service. We are in the process of replacing all current "T"s in service with Polytec "T"s. We expect to see improvements in system reliability not to mention safety considerations.
